February 13, 2013

Re: Sage Mine and Exploration Update, San Juan County, Utah

Sage Exploration (UTU-74646 and E/037/0184), Sage Monitoring Wells (UTU-74647 and

E/037/0188) and Sage Mine (S/037/0058)

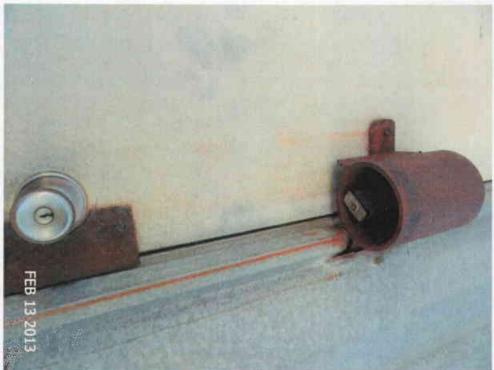
Vent Shaft Shroud welded on

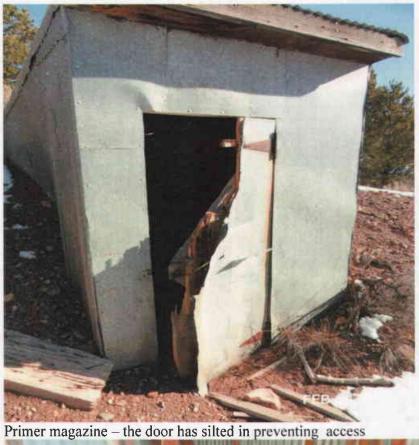
- General housekeeping, including removal of old hoses and debris, was completed in November.
- The powder magazine has been cleaned out but the door does not shut, as the floor has heaved. The primer magazine is empty and the door is partially silted in. we plan to repair and secure both doors in the spring.

Cleaned out powder magazine
